AVIATION MAINTENANCE ALERTS

Boeing: A75N1; Broken Engine Mount Bolts; ATA 7120

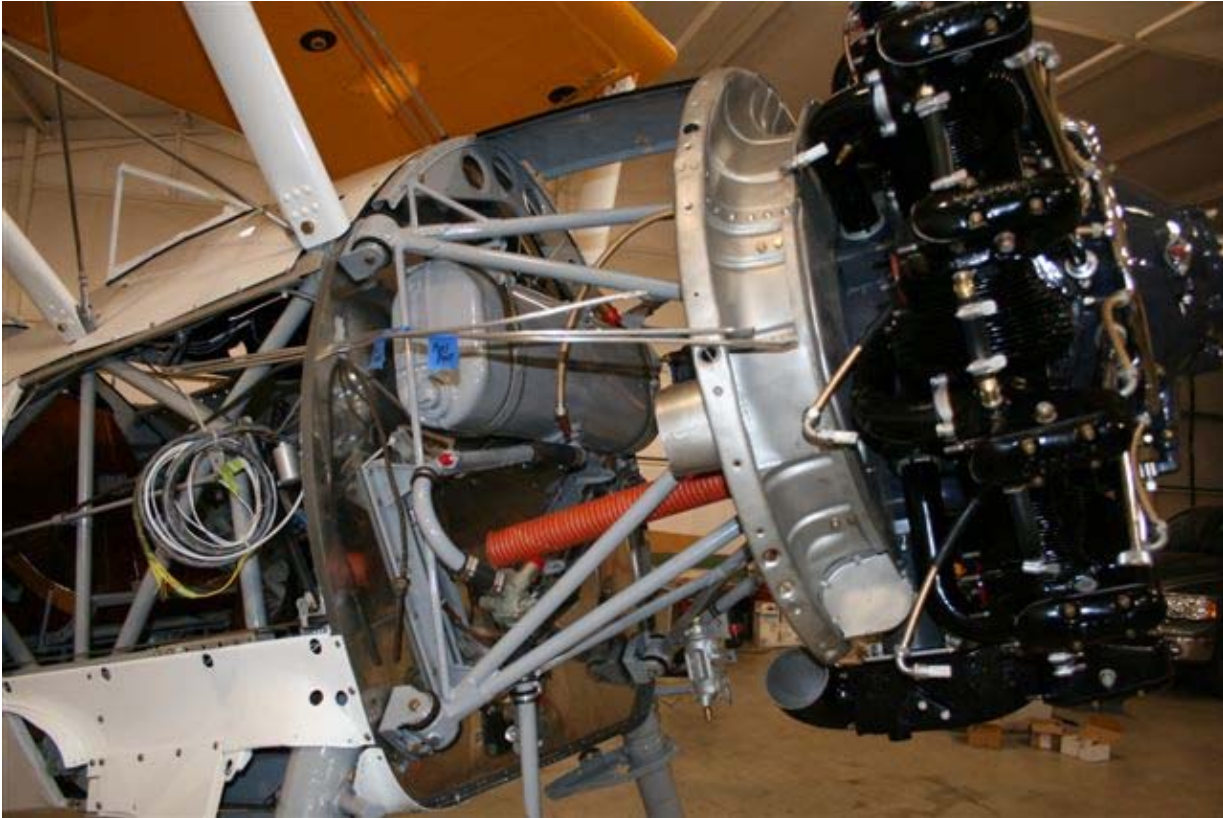
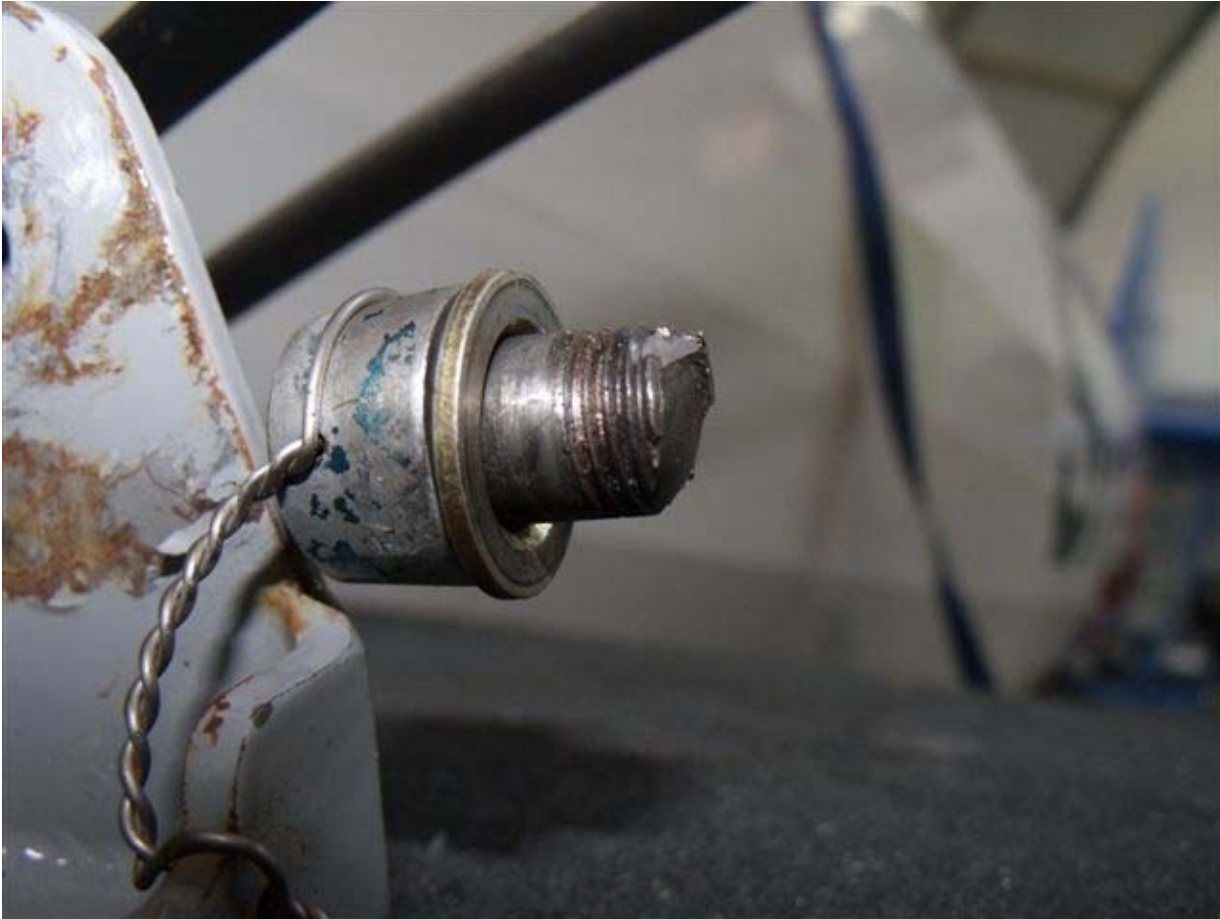
A mechanic states, "During inspection of the engine installation on this aircraft, it was determined that one of the four high strength NAS-148 bolts that hold the engine mount to the fuselage was fractured completely through -- under the head of the bolt. This bolt has 100 hours total time in service. After informing the STC (*supplemental type certificate*) holder of the failure, we were informed we should have re-torqued these bolts after 25 hours of operation. This information was not included in the STC. According to the STC holder (*this data*) was referenced in the original aircraft maintenance manual where it states the original engine mount 'studs' should be re-torqued to 450 to 500 inch-pounds after the first 25 hours. These original engine mount studs are not installed in the STC aircraft as they have been removed, and the entire assembly was replaced with a different mount and hardware assembly. The replacement bolts are NAS 148 (internal wrenching) and are oversize from the original studs. The original (*maintenance*) manual torque values would not be sufficient, and no further instructions (*were*) given.

"These bolts are hidden and it would require the removal of the engine to re-torque them. We believe a critical safety issue exists, as the failure of these bolts will result in a catastrophic (*accident*). (See accident report CA18/2/3/8321 where the failure of an identical bolt in a similar STC caused the separation of the engine and a fatality accident.) (*This*) STC is inadequate in its description for maintenance to ensure continued airworthiness."
